Study to Assess the Performance of Ceramic Diesel Particulate Filters for Reducing Diesel Emissions

K. Fields, W. Pomroy, G. Saseen & R. Haney

Mine Safety and Health Administration, Pittsburgh Safety and Health Technology Center, Pittsburgh, Pennsylvania, USA

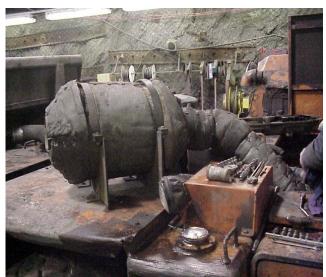
Figure 1. Installation of an Engelhard DPM Filter on a Haulage Truck.

The Engelhard DPM filters installed on the machines were based on a Corning cordierite filtration media that is wash coated with a platinum catalyst. The platinum catalyst is a second generation coating which means less platinum deposited on the cordierite. The platinum based catalyst provides the means for passive regeneration at a specific exhaust gas temperature. Passive regeneration occurs when the exhaust gas temperature duration is sufficient during the duty cycle of the machine to burn off the deposited DPM on the filter. This is successfully accomplished at an exhaust gas backpressure that does not increase above the recommended value specified by the engine manufacturer. During the study, all indications were that the filters were properly regenerating during the normal production duty cycle of the machines.
